FINAL REPORT OF
MILITARY POTENTIAL TEST
OF THE
ELECTRONIC BLADE TRACKER

DA PROJECT NO. 1D141812D18501

USATECOM PROJECT NO. 4-4-5003-01 ✓

U S ARMY
AVIATION TEST BOARD
FORT RUCKER, ALABAMA

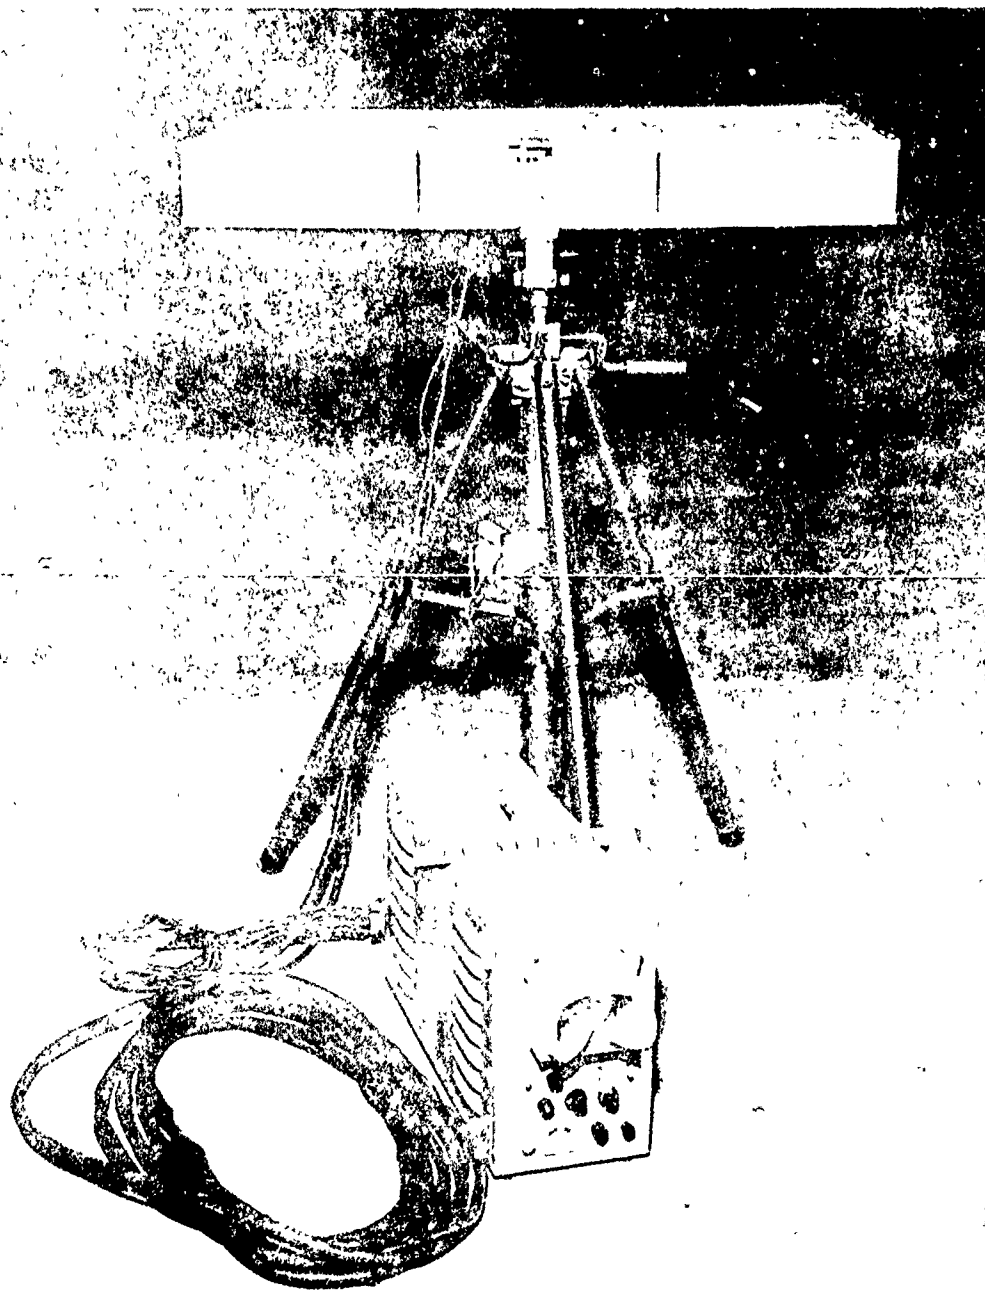
Model 1165B Electronic Blade Tracker

1.5.1. The Electronic Blade Tracker Model 1165B is a device for detecting differences in the rotational planes of helicopter rotor blades. The tracker consists of a scope assembly equipped with a 5-inch cathode-ray tube which displays the track condition of the blades, a stand assembly supporting a pick-up head assembly, and the necessary service and signal cables. The tracker requires either a 12- or 28-volt d. c. power source.

1.5.2. The tracker uses the capacitance principle to detect and display track condition. A capacitance signal, generated as the blade passes over the pick-up head, is converted to linear voltage and is displayed as a vertical trace line on the scope. The distance of the
